**PROCEEDINGS OF
THERMAL IMAGING FOR
REFRACTORY INSPECTION
AND PLANT MAINTENANCE**

**June 24, 1975
Pittsburgh, Pennsylvania**

Edited by Jan K. Eklund, AGA Corporation

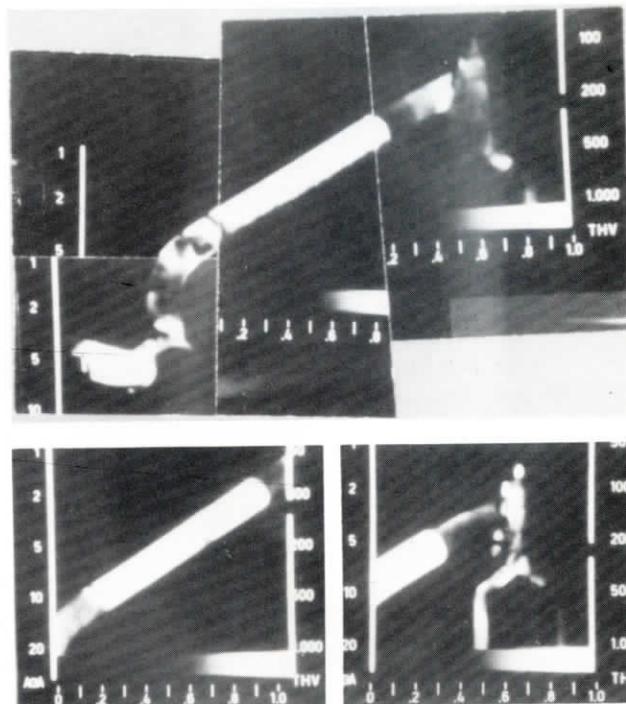
FIGURE 2

Based partly on the above inspection results, the entire downcomer and elbow were replaced and the upper section repaired. The thermograms shown at the bottom of Figure 2 were made after this replacement and as can be seen, the hot spots are no longer present.

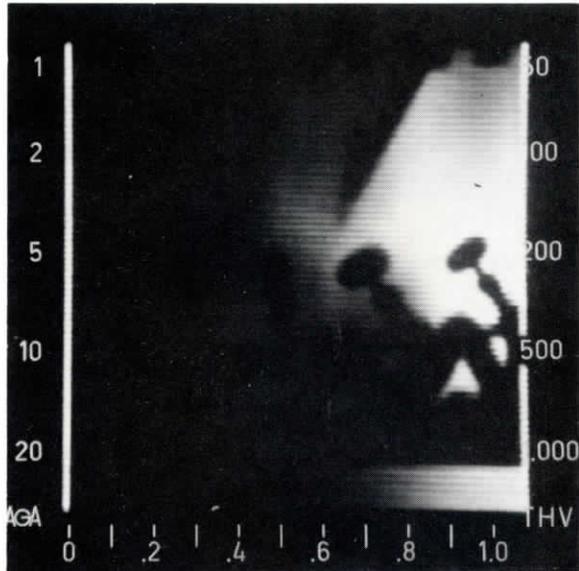
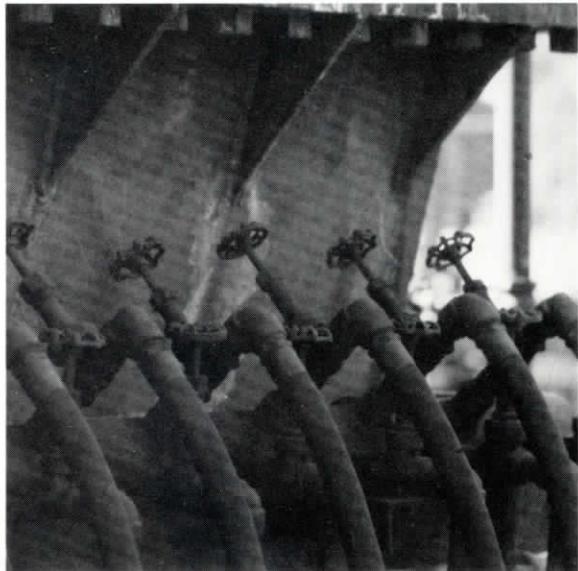
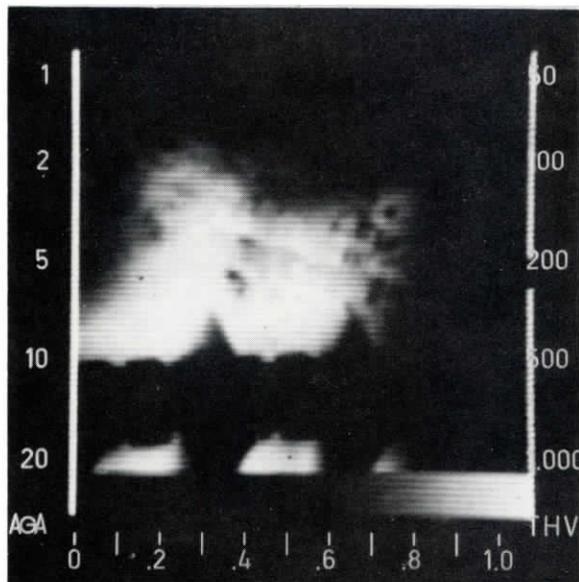
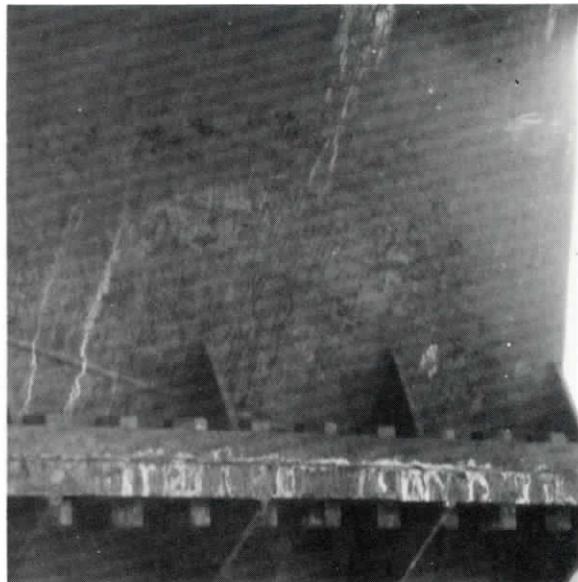
We were called to this blast furnace in an attempt to locate the exact section or sections. Three areas were suspected; the converging, throat and diverging sections of the scrubber system. The Thermograms revealed only portions of the converging and throat sections had lost some brick. See Figures 4a-d and 5a-d.

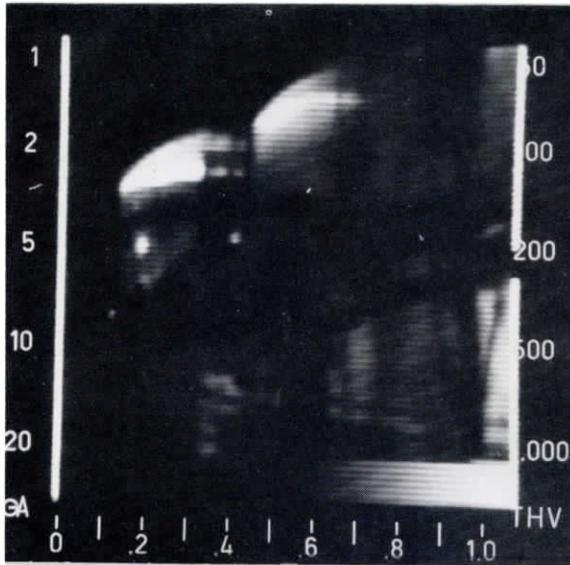
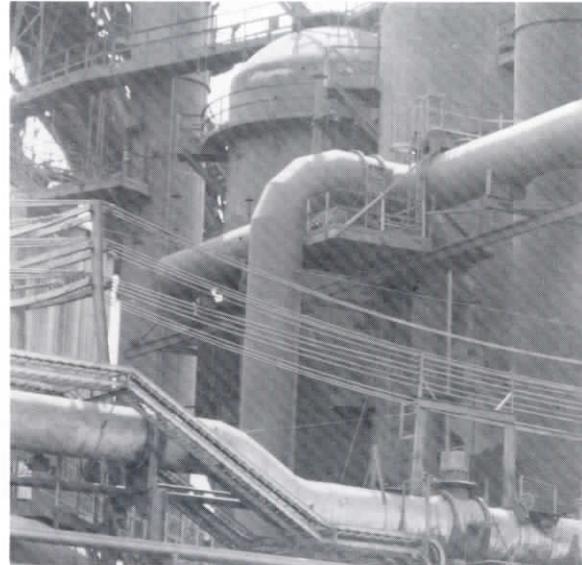
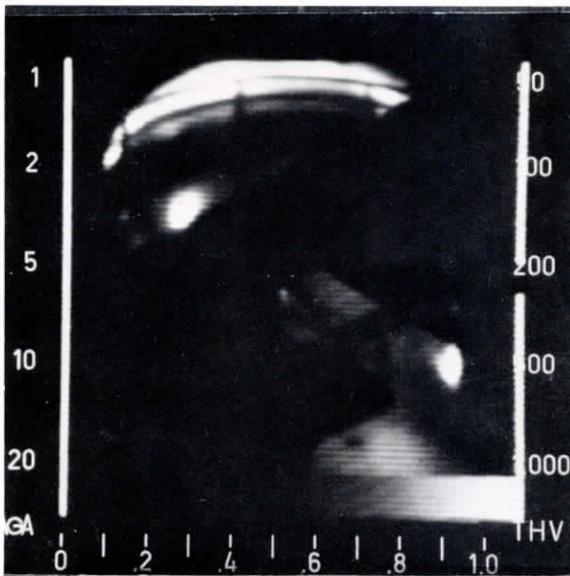
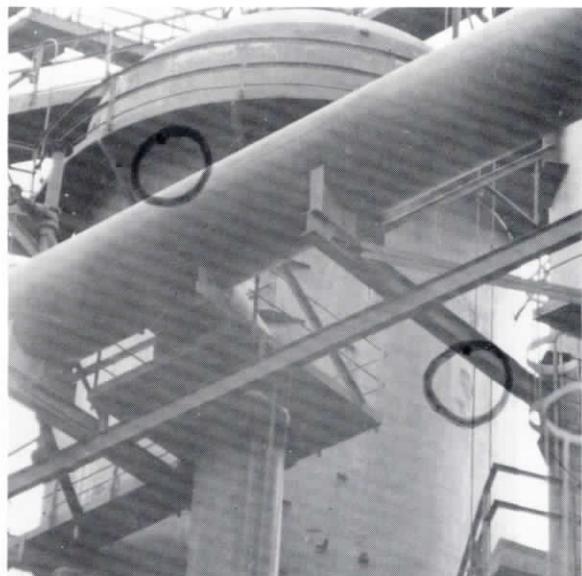
Two hot spots were discovered in No. 1 Stove, shown in Figures 6a and 6b. Figures 6c and 6d are close-ups of No. 1 Stove. These spots indicate either loose or cracked brick but at the time of inspection no great operating hazard.

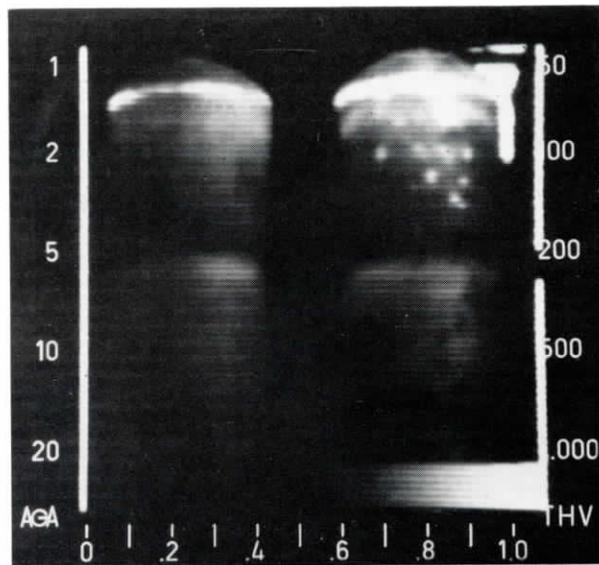
FIGURE 7b

In the thermogram on Figure 7b, No. 1 Stove (on the right) is on blast. When a stove is on blast, the greatest movements of the hottest gases takes place. All inspections of stoves are completed during the blast cycle. No. 2 Stove on left in right thermogram has uniform thermal patterns but is not on blast. In the left thermogram, Figure 7a, No. 2 Stove (on the left) is on blast and still has a uniform heat pattern. No. 1 Stove on the right is starting to "soak out" causing the spots to merge into a single hot area. Ore pile seen in Figure 7c is not visible in thermograms.

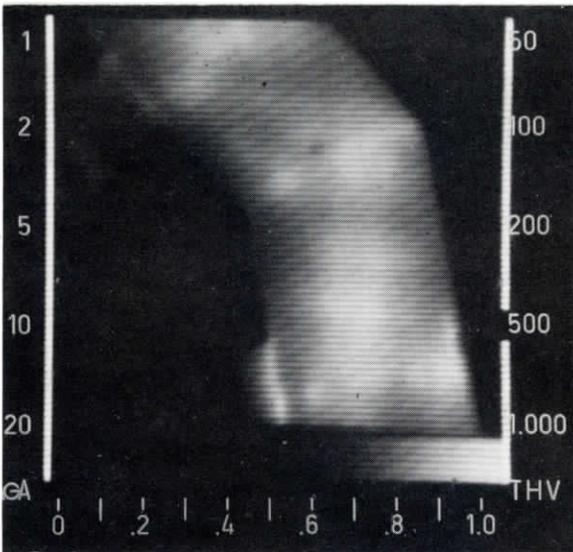
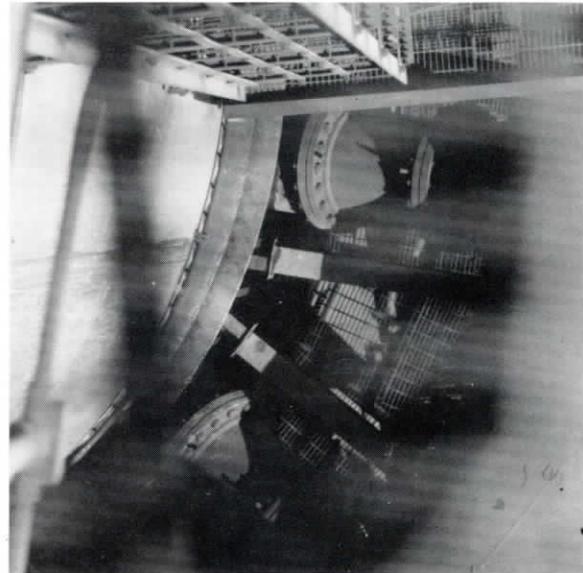
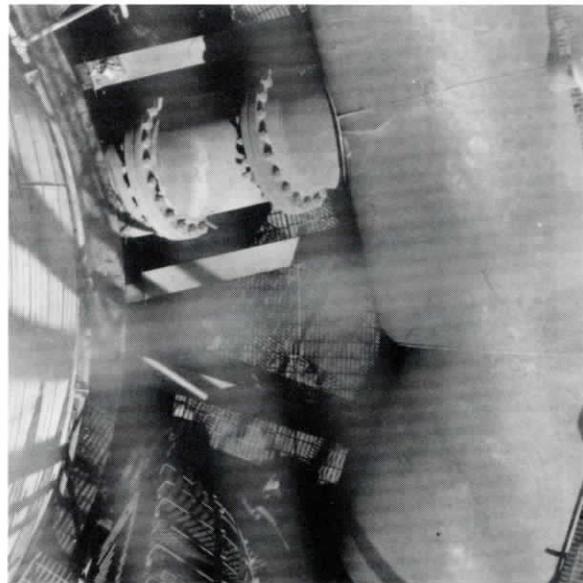
$\text{CO}+\text{H}_2$ gases enter the bustle pipe and through 12 tuyeres into the DR shaft. The area where the tuyeres join the bustle pipe was suspected of containing loose or thin refractory brick. As seen in Figures 12a-d there is an uneven thermal pattern. The thermograms are mirror images of the real pictures.

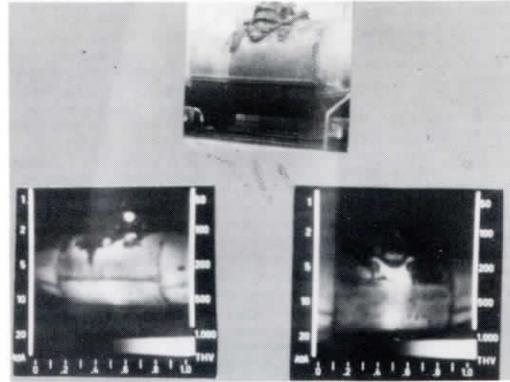
FIGURE 16

Figure 16 shows a hot metal car with a localized hot spot in the collar area. The temperature in this spot was 670° F. When the car was inspected visually, there was evidence that the hot metal had penetrated the mortar between the bricks and solidified. Based on these findings, the car was only filled to one-half of its capacity until repairs could be made.

The cars shown in Figure 16 are typical of most of those in service. When hot spots are detected, they generally occur in the collar area or in the bottom of the ladle where hot metal strikes the bricks

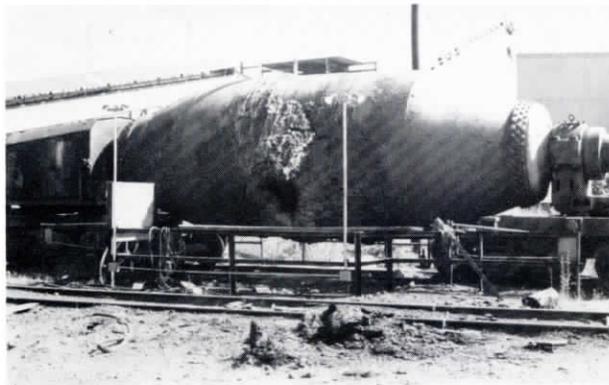
FIGURE 17

Figure 17 is a view of a hot metal car in position for repair work. Figure 18 was taken inside this car while in this position. Note cobblestone effect in brickwork.

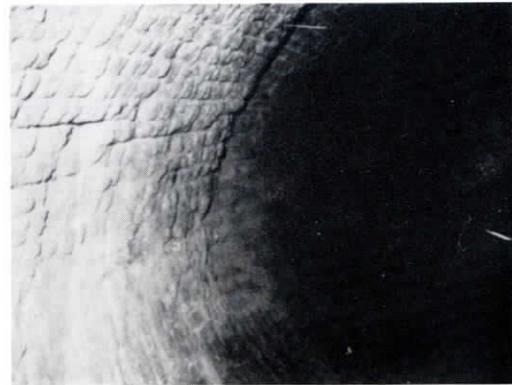
FIGURE 18

directly during casting. Figure 18 was taken inside one of the cars. With the car rotated, the collar area is at the lower right making the bottom at upper left. The cobblestone appearance results from wear in the mortar joints. The groove is caused by hot metal striking the bricks during casting. Some hot areas have also shown at the slag line where there tends to be an erosion due to splashing. Hopefully, the data obtained from these inspections can be used to determine the amount of brick remaining and can be used to predict when relining is necessary.

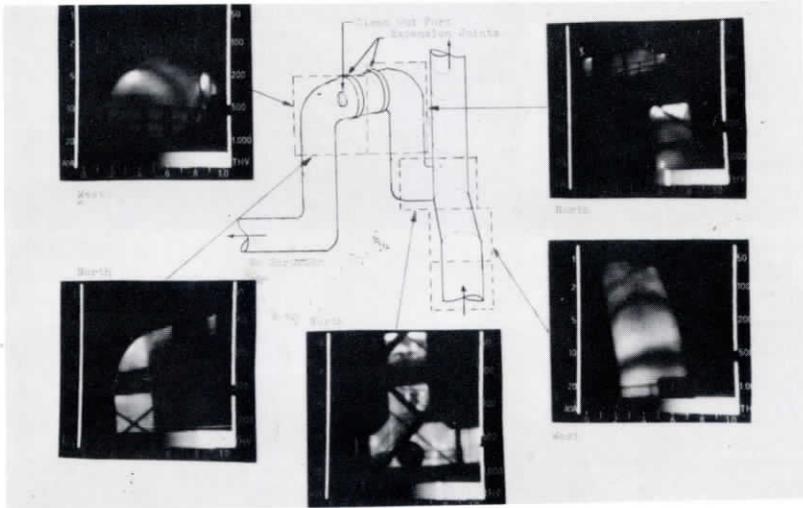
FIGURE 19

areas covered by each frame. In the thermograms at the upper right, bottom and lower left, an isotherm was used to map out the hottest areas. In general, except for the clean out ports, the hot spots were less than 25° above the nominal duct temperature and not considered serious. The thermograms are retained for reference and when the inspection is repeated, any changes in size or temperature will be noted.

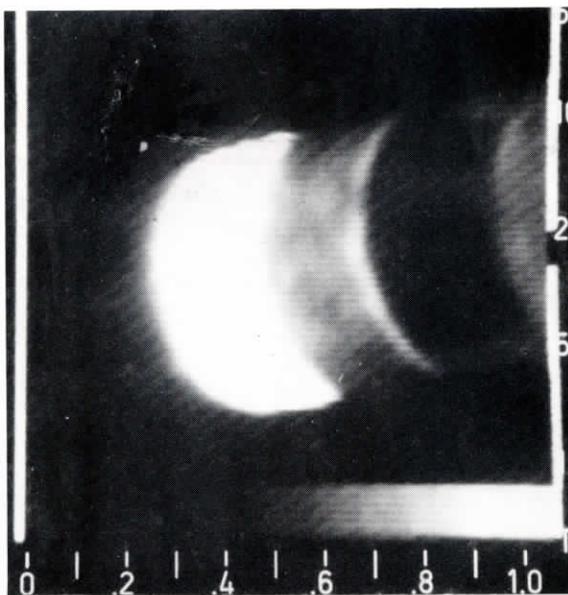
FIGURE 24

Figure 24 is a close up of the kiln. Heat ring is present because of thin bricks. Two types of brick are used in this area and one type wears more rapidly than the other. Eventually this ring will extend to the right as the wear increases. The dark patch 6'x8' is a piece of aluminum foil between brick and kiln wall. This foil was put in by maintenance foreman as an experiment. The temperature is 25° F cooler on kiln surface at this patch.

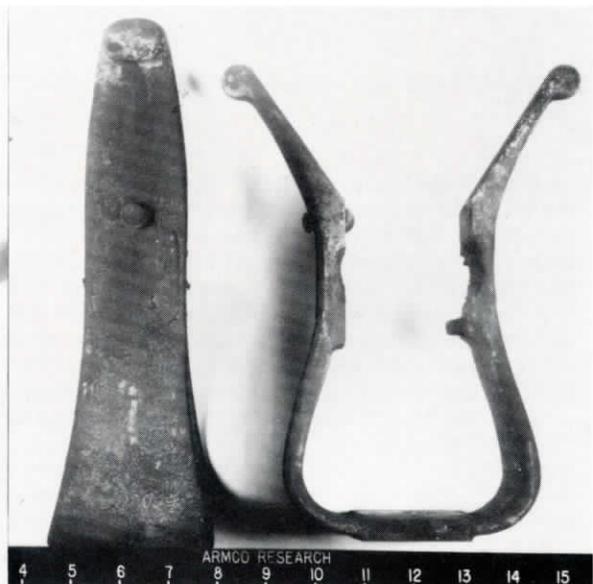
FIGURE 27

The breaker jaw, shown in Figure 27, is typical of those that are defective. Note the wear.

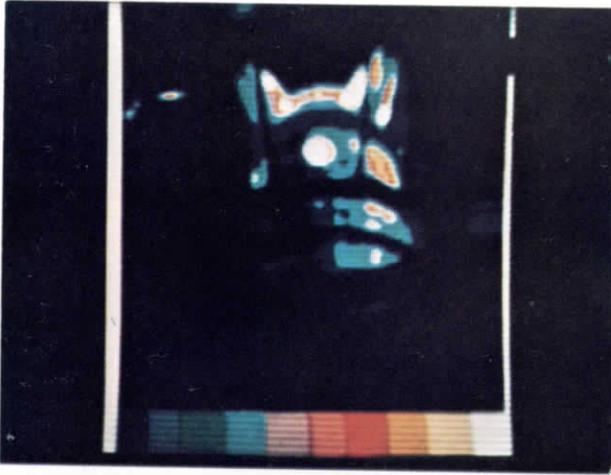
FIGURE 14 Photograph and thermograph of blast furnace stack showing higher temperature area caused by worn lining.

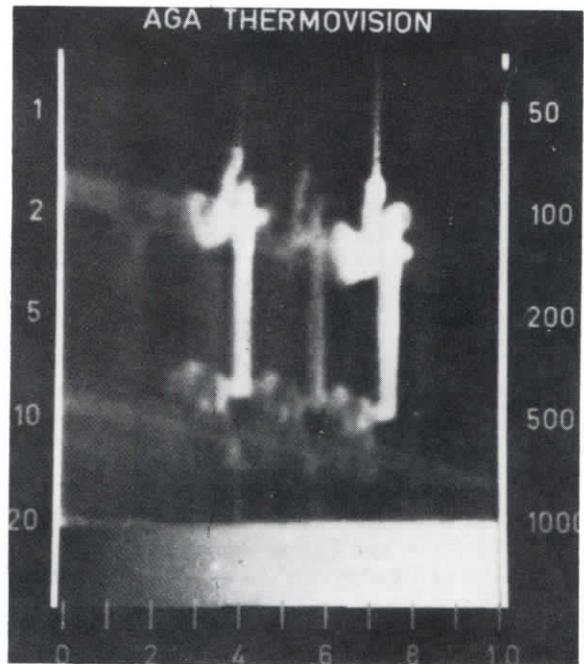
FIGURE 21 Thermograph of disconnect switch in power grid; the two hot links are clearly shown. (Courtesy of Davey Infrared Systems)

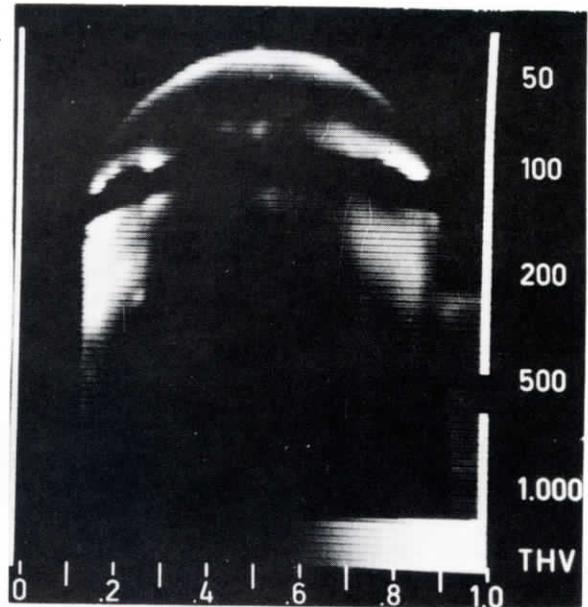
On one of the resulting thermograms (see Figure 5) a hot area could be found up near the dome.

FIGURE 5 Hot spot on stove (measured to 150°C)

In this case it was decided that the stove could be operated but under surveillance and under continuous waterspraying up to a planned repair date some three months later despite the total loss of refractory with the insulation layer fully exposed. The diagnosis was confirmed when the stove was closed for repair.

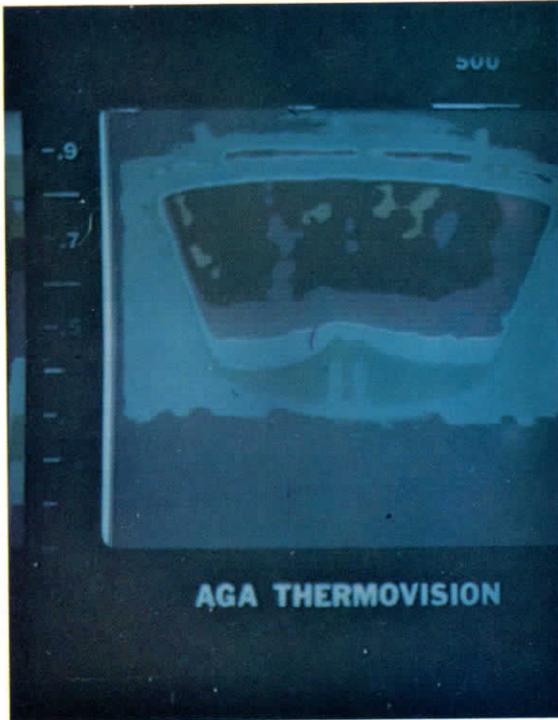
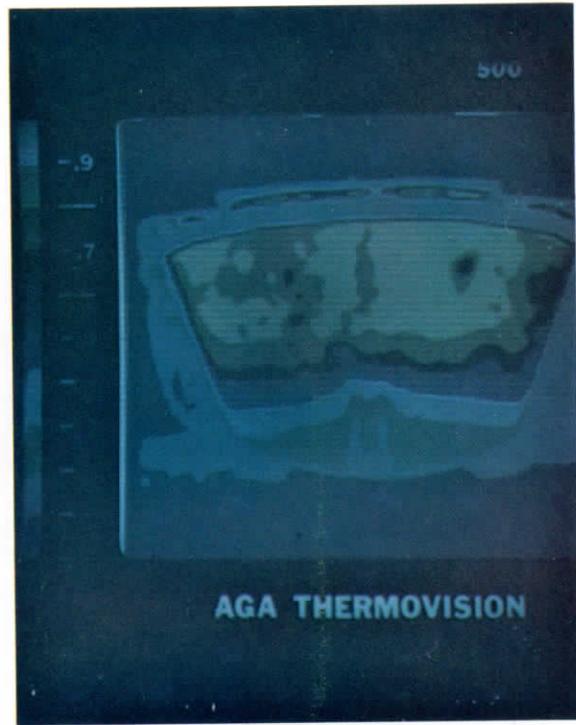
FIGURE 5

The contrast of temperature distribution on the vessel surface is demonstrated by picture X2 (Heat No. 7) and H (Heat No. 15) (Figure 5). A shift upward of approximately 40° F appears to have occurred in the warmer regions. 440° F and above. The magenta band of Heat No. 7 has been replaced by red and most of the orange band in Heat No. 15; a temperature increase of 25 to 50° F. The large red area of Heat No. 7 has shifted to yellow in Heat No. 15, representing an increase of approximately 25° F. In Heat No. 7 the temperature range was 184° F while Heat No. 15 it was 205° F. Heat patterns generally conformed to these same basic patterns throughout the study.
