Eklund Infrared Newsletter 0606RMrfi.

A story on how a DayCor® Solarblind Camera helps solve a nasty RFI (Radio Frequency Interference) problem.

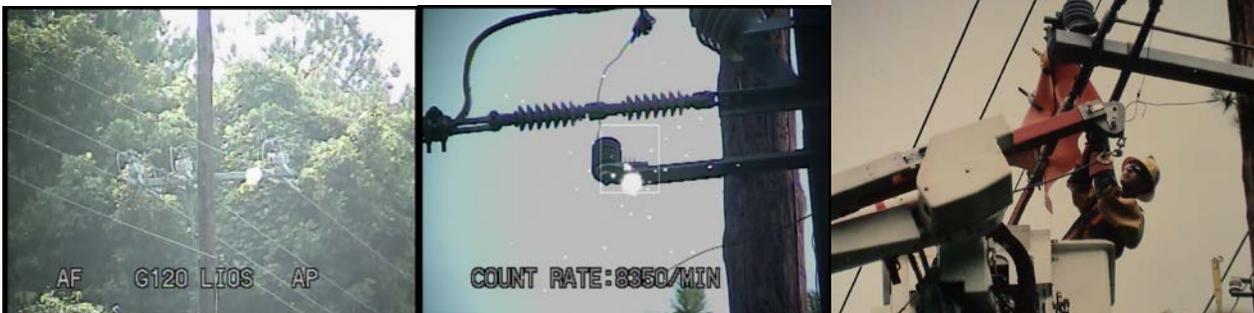
Moving the DayCor® camera to this location for a closer look, arcing was detected at the bottom of a lightning arrester. **The arcing strength was measured with the DayCor® Corona Camera counter and was found have a count rate of 8,000 to 10,000, extremely high!** The location of the arc was between the bottom of the lightning arrester and the support bar. A lightning strike had shorted out the lightning arrester and burnt out the grounding wire.

Arcing corona seen hundreds of feet away on hazy day.

The exact corona arcing location

Lineman from EMC takes down the faulty arrester

The **local EMC** called in one of their bucket trucks and the faulty lightning arrester was disconnected and brought down for evaluation. It had **zero Ohm** resistance and was discarded. **The Radio Amateur Operator reported that all the radio interference was now gone and the noise level was measured to be below S1. Success!**

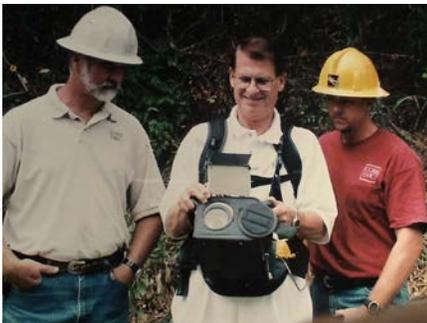
EMC crew studies the Corona Camera image(DayCor®II)
