**PROCEEDINGS OF
THERMAL IMAGING FOR
REFRACTORY INSPECTION
AND PLANT MAINTENANCE**

**June 24, 1975
Pittsburgh, Pennsylvania**

Edited by Jan K. Eklund, AGA Corporation

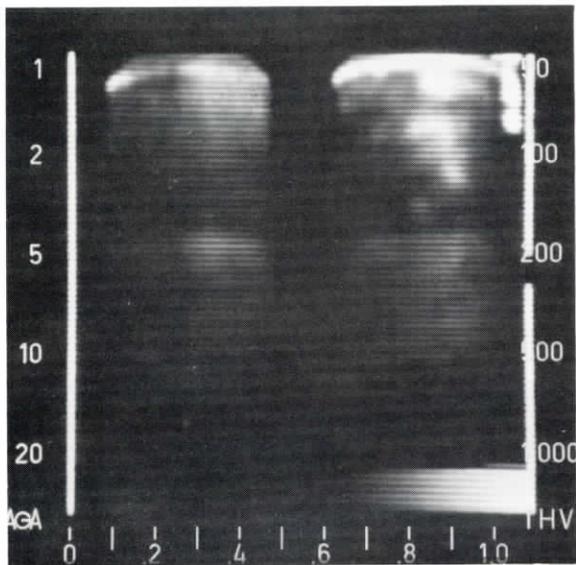
FIGURE 7a

In the thermogram on Figure 7b, No. 1 Stove (on the right) is on blast. When a stove is on blast, the greatest movements of the hottest gases takes place. All inspections of stoves are completed during the blast cycle. No. 2 Stove on left in right thermogram has uniform thermal patterns but is not on blast. In the left thermogram, Figure 7a, No. 2 Stove (on the left) is on blast and still has a uniform heat pattern. No. 1 Stove on the right is starting to "soak out" causing the spots to merge into a single hot area. Ore pile seen in Figure 7c is not visible in thermograms.

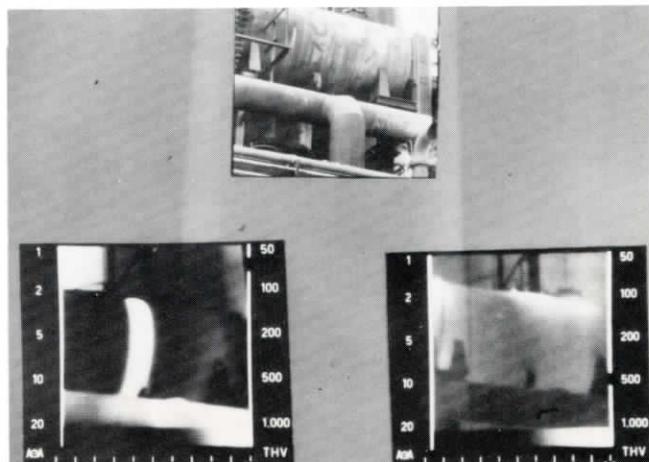
FIGURE 8

At the top of Figure 8 is a photograph of the hot blast main which interconnects the stoves with the furnace. During an evening shift, a glowing hot spot appeared on the upper surface. The following day, the lower left thermogram was made showing the hot spot that was seen at the top went completely around the duct. On visual inspection during the next shutdown, it was found that a complete row of bricks had fallen from around the circumference. These were replaced and the present condition is shown at the lower right. Here, the thermal map provided some indication as to the amount of rework necessary.

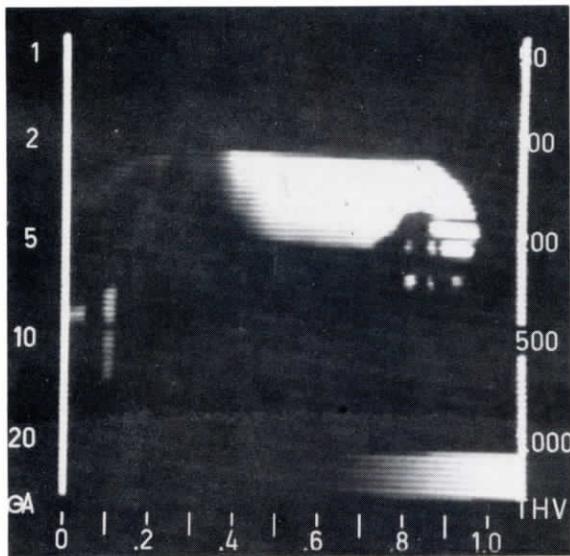
FIGURE 9a

Figures 9a and 9b shows the emergency cold blast main. This line supplies a cold blast into the hot blast main in an emergency situation. There should be no gas movement, nor elevated gas temperature in this line during normal operations.

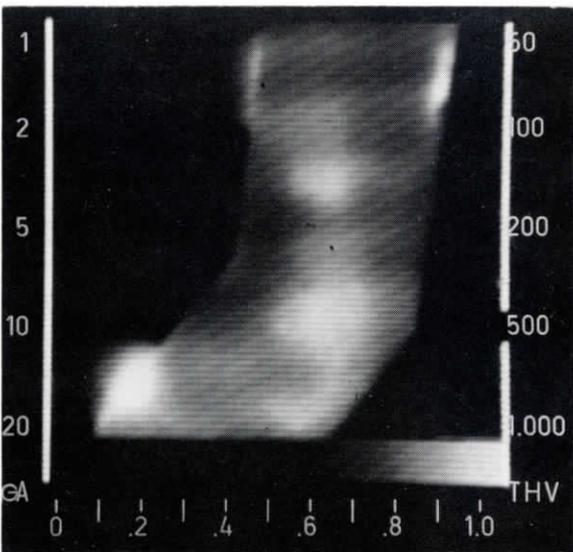
FIGURE 12c

$\text{CO}+\text{H}_2$ gases enter the bustle pipe and through 12 tuyeres into the DR shaft. The area where the tuyeres join the bustle pipe was suspected of containing loose or thin refractory brick. As seen in Figures 12a-d there is an uneven thermal pattern. The thermograms are mirror images of the real pictures.

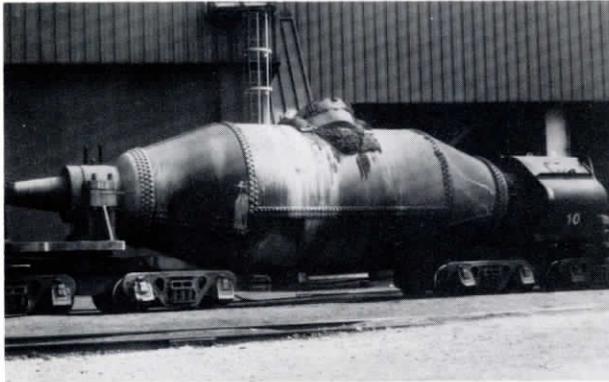
FIGURE 15

Another inspection program, shown in Figure 15, concerns Pugh-type hot metal cars used to transport pig iron from the blast furnace to other processing areas. These cars are refractory lined vessels which can carry up to 300 tons of molten metal. Here, the Thermovision is used to locate hot spots which could lead to dangerous breakouts through the shell of the car. Based on our experience to date, the typical skin temperature of a full car is approximately 380° F. During one inspection, the temperature of a hot spot in the collar area of a car exceeded 650° F and soon after, a breakout occurred. Based on this experience, all hot spots in excess of 600° F are reported and the car, when cooled, is inspected visually and corrective action taken.

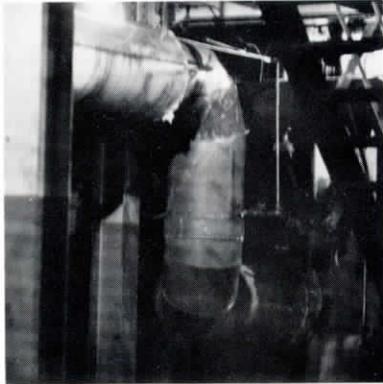
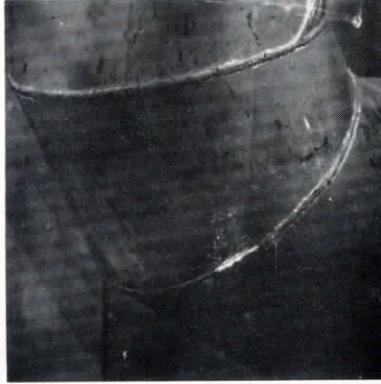
Most of the items which have been discussed were concerned with areas where thermal inspections are done as part of a routine maintenance program. In addition to this, a couple of interesting special inspections were requested. One concerned a blockage in a 26" gas main which carries blast furnace off-gas to the coke ovens where it is used for fuel. The coke oven operators had noted that over a period of time, the fuel air ratio was constantly increasing to maintain the ovens at the proper temperature. A differential pressure measurement revealed that there was a restriction somewhere in the transition section shown in Figures 20a-e. Closeup of lower elbow is shown in Figure 20b. With a thermal inspection, the obstruction was found to be at the bottom elbow where apparently the dust and dirt associated with blast furnace gas had accumulated. The thermograms, Figures 20c-d-e, were taken over a six month period as various methods were tried to dissolve the obstruction by injecting steam, chemicals, etc. just above the elbow. As can be seen in the Figure 20e thermogram, the only remaining solid matter present is in the very bottom of the elbow.

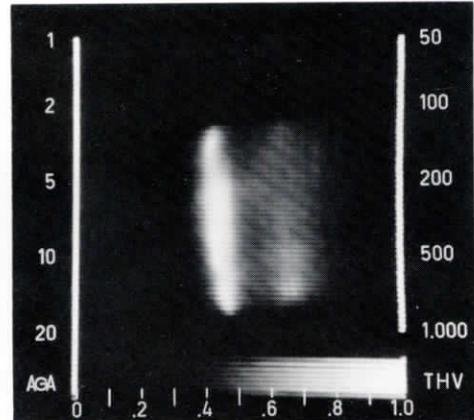
FIGURE 22

Figure 21 is a view of a kiln at one of our limestone mines. This rotating kiln is 300 ft. long and 10 ft. in diameter. Limestone enters at right into the kiln and moves down and to the left of the picture. Figure 22 is a thermogram showing the firing zone at the left of the kiln. Varied heat patterns are due to thin brick.

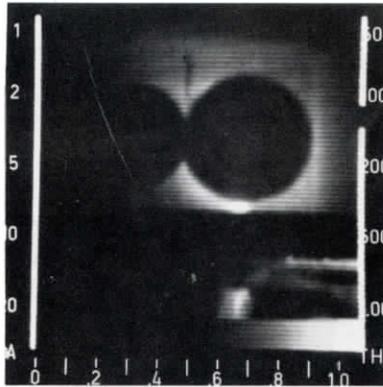
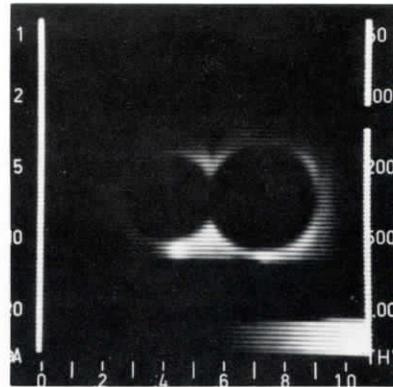
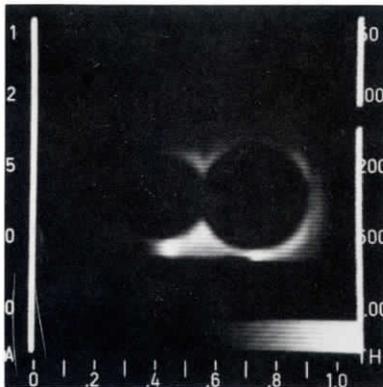
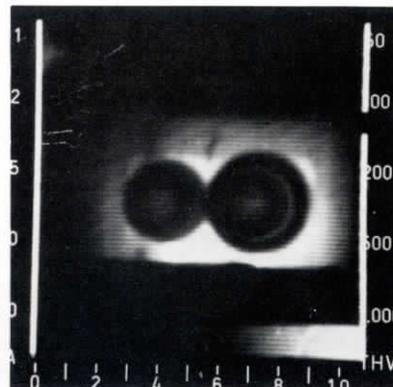
Another area of concern is gear boxes. There is not much information or data available at this time. Shown in the thermograms, Figures 25a-d, are gear boxes located on a large coupling threading machine. The temperature range is from 110-145° F. There have been bearing problems in these machines and an attempt is being made to see if we can isolate the problem through thermal techniques.

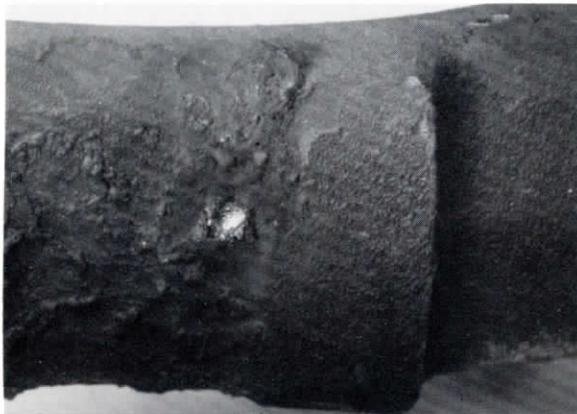
FIGURE 28a

Figure 28 is a close up of one side of the breaker jaw. There is intimate contact at one point only. Figure 28b is a thermogram taken during October 1973 inspection of this same switch.

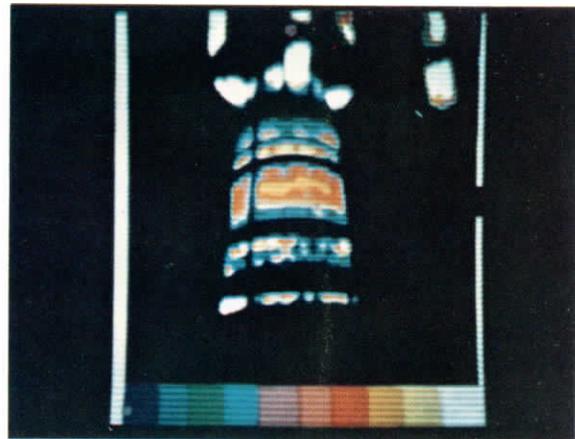
FIGURE 3 Thermograph of blast furnace. Note hotter offtakes at top; dark bands around furnace are catwalks.

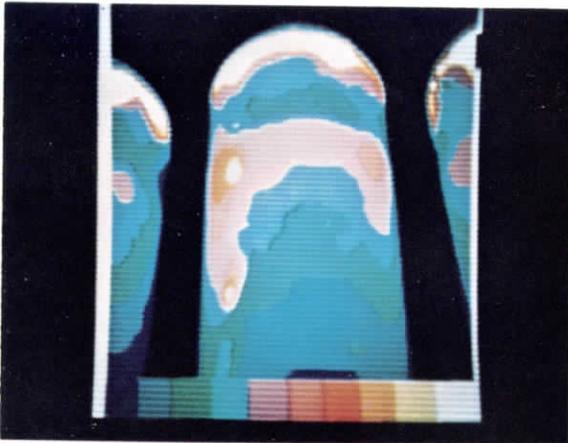
FIGURE 15 Thermograph of hot blast stoves showing thermal pattern on the stove shells.

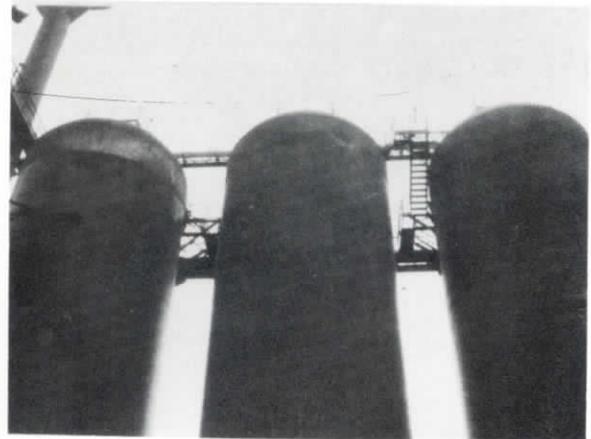
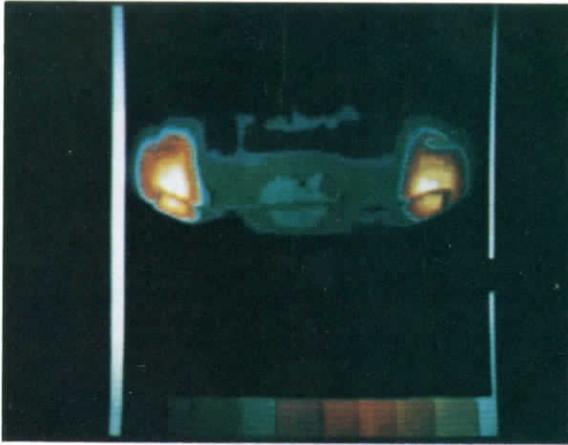
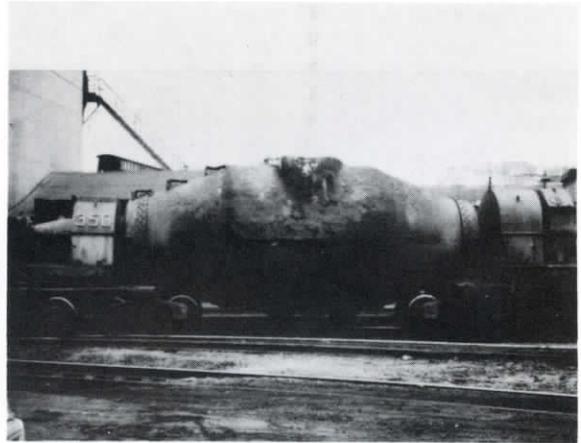
face temperature distribution on submarine hot metal cars. Figure 16 shows the temperature distribution along a series of pictures that shows the growth in higher temperature areas on a ladle car over a period of three months. U.S. Steel is applying this technique to a study of temperature changes in ladle cars, and will attempt to relate

FIGURE 16 Photograph and thermograph of submarine-type hot metal car, showing hotter areas in reds and yellows.

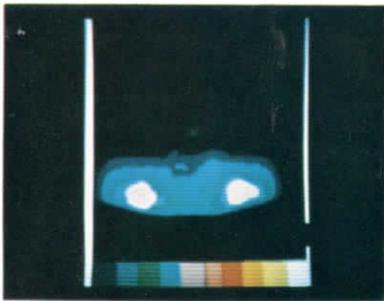
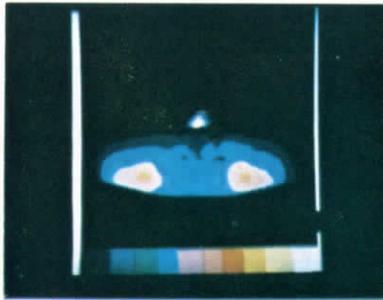
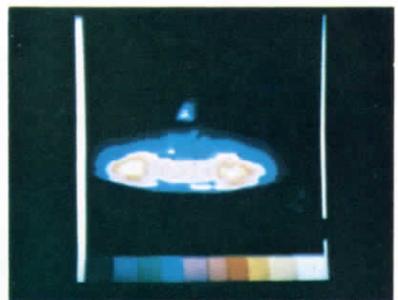
FIGURE 17 Three thermographs taken a month apart, showing the progressive growth of hotter area on a single hot metal car.

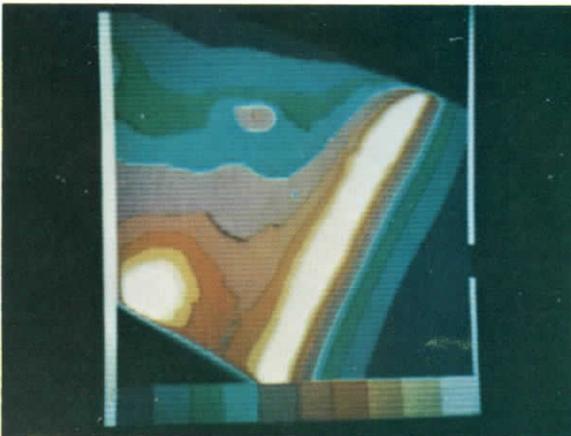
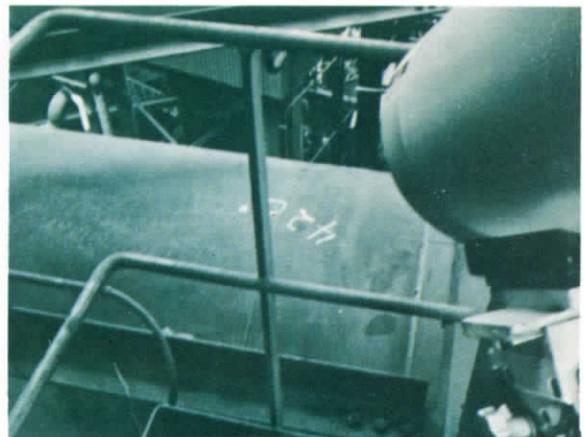
this to refractory lining thickness and to explore methods of temperature measurement that will attain maximum lining life consistent with operating safety. Figure 18 shows a thermal image taken on a hot blast main to examine areas around refractory joints.

FIGURE 18 Photograph and thermograph of a portion of a hot blast main, showing thermal pattern.

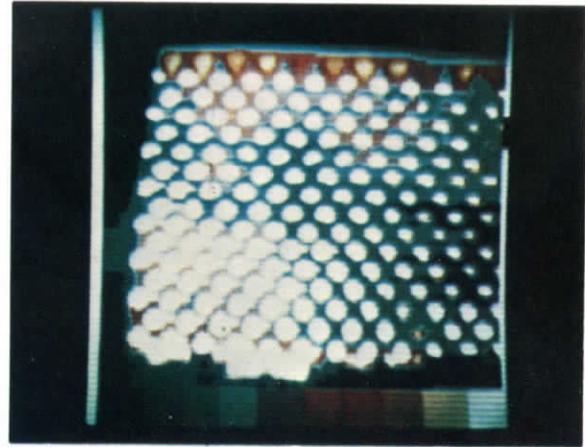
FIGURE 19

Another useful furnace application is shown in Figure 19's thermal image of a recuperator on a reheat furnace at one of our plants. The furnaces preheat air temperature was not as high as design standards; an initial phase of a study to improve efficiency was to take a series of thermograms of the preheat air system. Air is preheated in a bank of horizontal stainless and refractory tubes called a recuperator. Hot flue gas passes around the outside of the tubes on its way to the chimney; combustion air is drawn through the hot tubes and is discharged into the gas burner. The intake ends of the tubes are open to atmosphere, and they discharge into a plenum chamber from which air is drawn for the gas burner. The thermograph shows the ends of the tubes, hotter where exhaust gases enter the stack at the left, and gradually colder

toward the exhaust gas discharge flue. Plant operators plan to make changes that will raise temperature of the intake air.

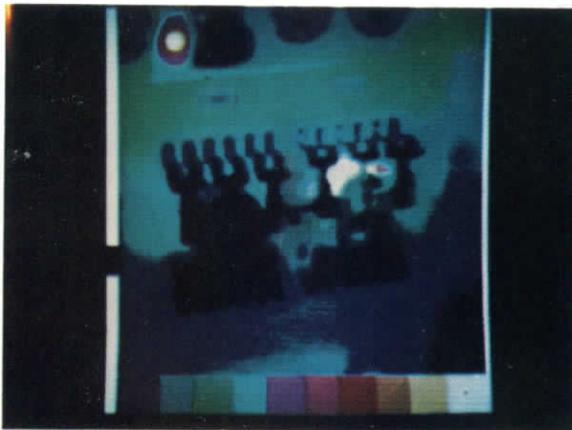
FIGURE 20 Photograph and thermograph of relay panel in mill electrical area. Overheated components are easy to find.

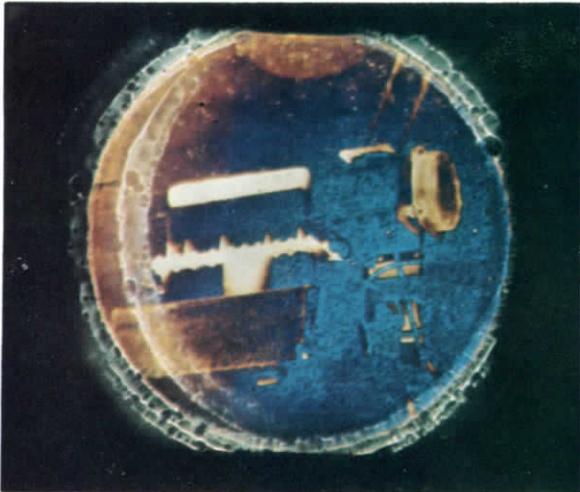
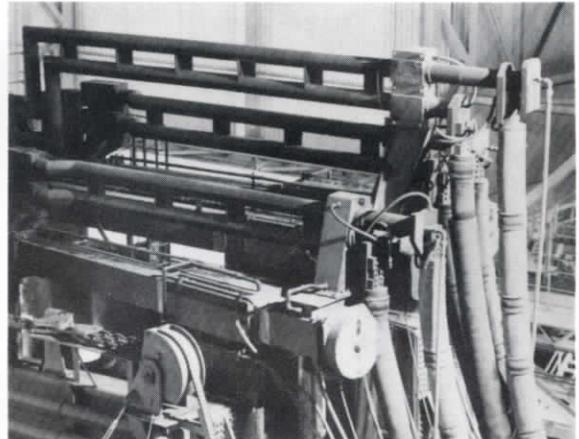
A major factor in the usefulness of thermal imaging in electrical systems is that measurements are made without contact, and can be made from a considerable distance, so that temperatures can be measured at operating loads and potentials. This characteristic was most helpful in U.S. Steel's study of heating in electric furnace mast arms, Figure 22. Serious problems were encountered with high current (up to 95,000 amperes) inductive heating of certain components in the carbon-steel electrode mast assemblies of a 200-ton electric arc-furnaces. Thermal images quickly located areas of overheating and gave continued, qualitative temperature distribution pictures during design changes that eliminated the problem.

FIGURE 22 Photograph and thermograph of electric furnace mast arms made during studies of mast-arm heating on new high-current electric furnaces. The thermograph was made by an instrument named the Evaporograph, formerly made by the Baird Atomic Company.

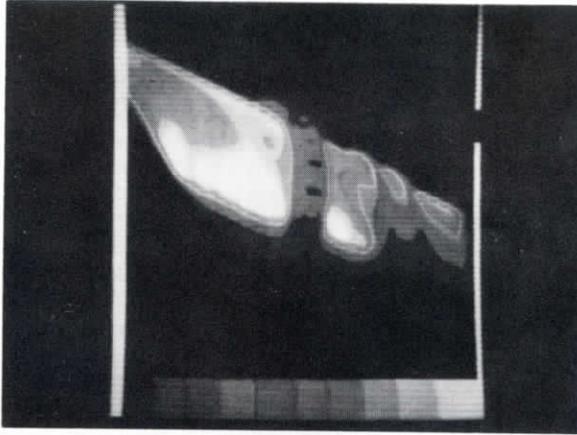
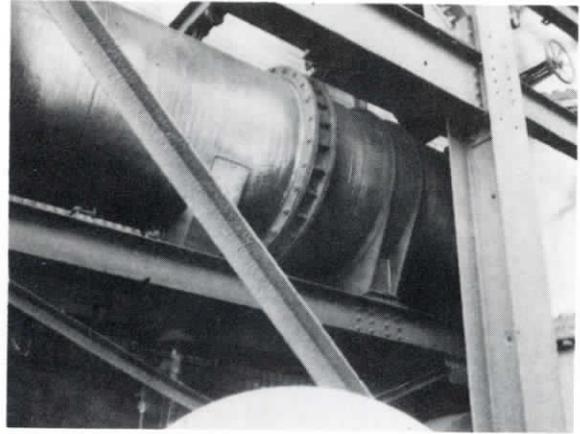
Thermal imaging has considerable use in diagnosing problems in ducts and process piping. Consider gas ducts, Figure 23. Gases go through the duct and as often as not deposit sludge on the bottom of the duct. The sludge buildup acts as something of an insulator; the temperature of the duct that is covered by sludge will be different from that where the walls are bare. A thermal image of such a duct locates the extent and distribution of deposits that have settled on the bottom. (This, of course, holds true only if the gases traveling through the duct are sufficiently colder or hotter than the ambient surroundings.) One of the more interesting images is that of a tar storage tank, Figure 24. The tar is stored hot to keep it fluid, and this image of the tank shows a most interesting situation. The warm band is about 2° F higher than the surroundings, and is due to freshly pumped warm tar. The white area on the right-hand fifth of the image is due to sunlight warming the surface; a similar effect on the adjacent tank is easy to see; the shadow cast by the right-hand tank is visible as a blue area, and sunlit area appears magenta. Steam lines show white, and the hot gases from a distant stack show as a white puff over the top of the left-hand tank.

FIGURE 23 Photograph and thermograph of ducts in coke oven area. Distribution of temperature on duct surface will indicate degree of sludge deposit in duct, provided that gas temperature is different from ambient temperature.

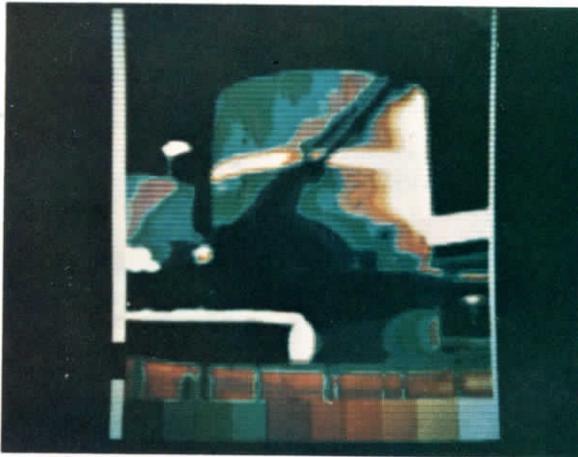
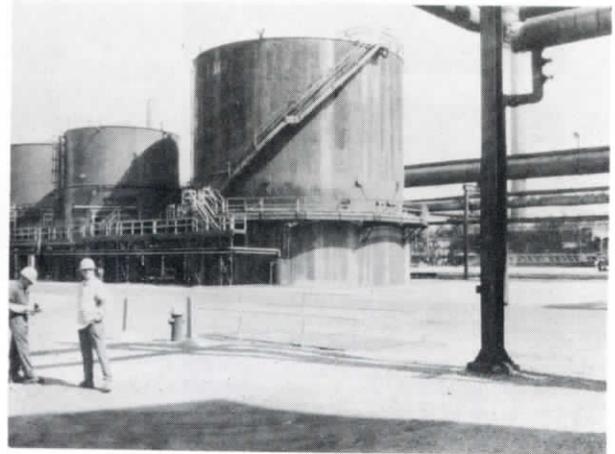
FIGURE 24 Photograph and thermograph of tar storage tank. The light band represents hot tar resting on cooler matter, presumably sludge. The lighter area at the right-hand side indicates that hot fluid flows down to drain at bottom of tank.

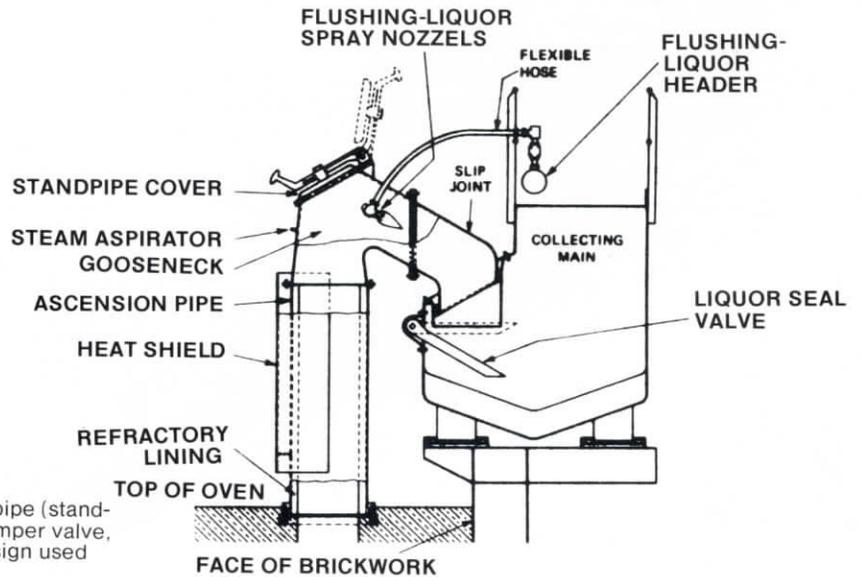
A very difficult thermal imaging job was the diagnosis of temperature distribution on a coke oven gooseneck, a casting that couples the riser from the end of a single coke oven to the collection main that goes along the sides of the entire battery of ovens, as shown in Figure 25. The gases given off by the coal in the oven travel up through the riser, around the gooseneck and into the collection main. During operations at a coke plant, it was noticed that some goosenecks were overheating, apparently, and were cracking. Attempts to measure the temperatures with temperature-indicating crayons were unsuccessful. A thermal imaging unit was mounted with a clear view of the gooseneck, and Polaroid pictures were taken during the critical part of the heating just as fast as operators could pull the tabs out of the film pack, Figure 26. These time series of temperature distribution proved most illuminating; thermocouples were placed at locations indicated by the thermograms, and subsequent thermal studies of temperature transients showed the problem of the deterioration and how to overcome it.

FIGURE 25 Section through an ascension pipe (stand-pipe), elbow (goose-neck), liquid-sealed damper valve, and collecting main of a typical off-take design used by Koppers Company.

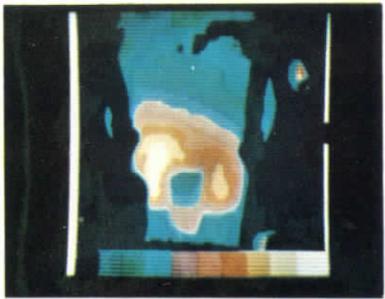
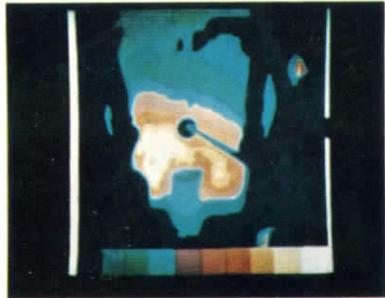
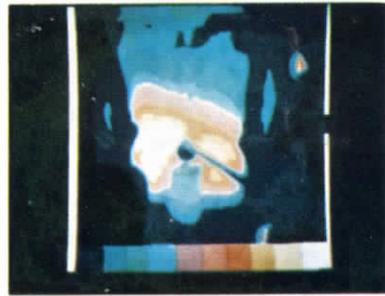
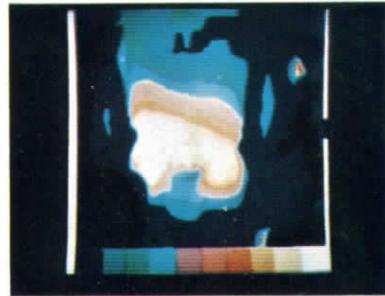
FIGURE 26 Thermographs of rapidly changing heat pattern on gooseneck castings at coke oven battery.

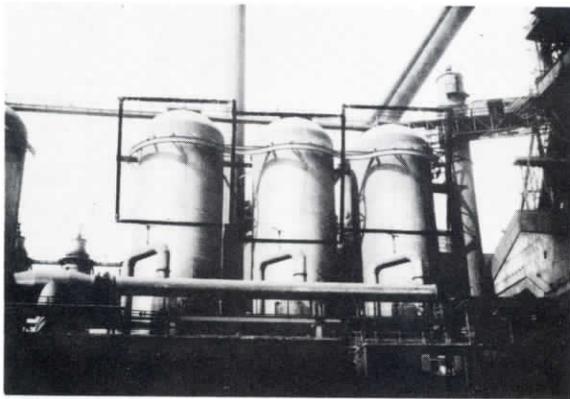
The middle stove in a set of three (see Figure 4) has been noticed to be overheating and refractory bricks had been found on the bottom of the stove.

FIGURE 4 Visual Photograph of three stoves.

In this case it was decided that the stove could be operated but under surveillance and under continuous waterspraying up to a planned repair date some three months later despite the total loss of refractory with the insulation layer fully exposed. The diagnosis was confirmed when the stove was closed for repair.

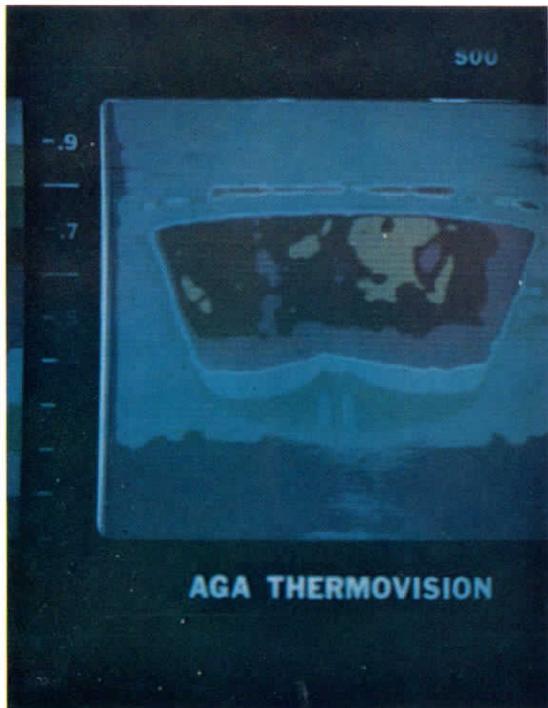
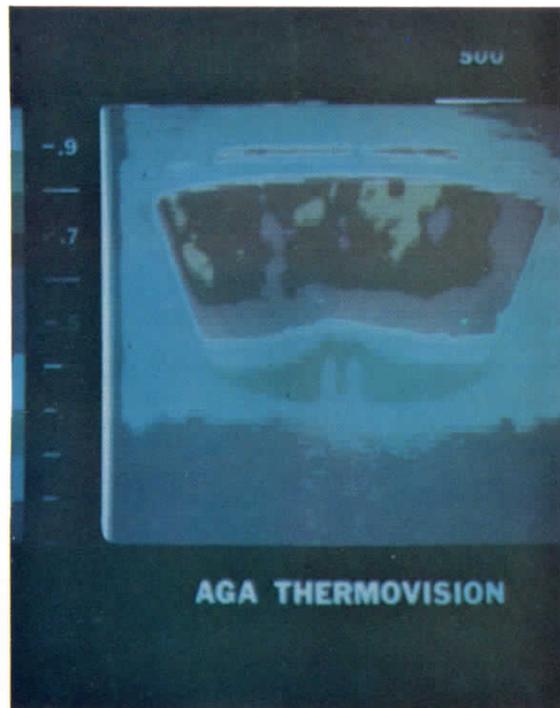
FIGURE 2

Figure No. 2 identified as 2 and 7, taken during the course of Heat No. 7, display an isotherm pattern on the vessel surface representing a temperature range of 184 degrees F. The coolest area (dark green) at the base is 328 to 376°F and the warmest areas (orange) reaches 512°F. The various bands represent the following temperatures:

White	533 - 550°F (17)
Yellow	512 - 533°F (21)
Orange	489 - 512°F (23)
Red	465 - 489°F (24)
Magenta	440 - 465°F (25)
Purple	411 - 440°F (29)
Light Green	376 - 411°F (35)
Dark Green	328 - 376°F (48)
Light Blue	258 - 328°F (70)
Dark Blue	32 - 258°F (126)

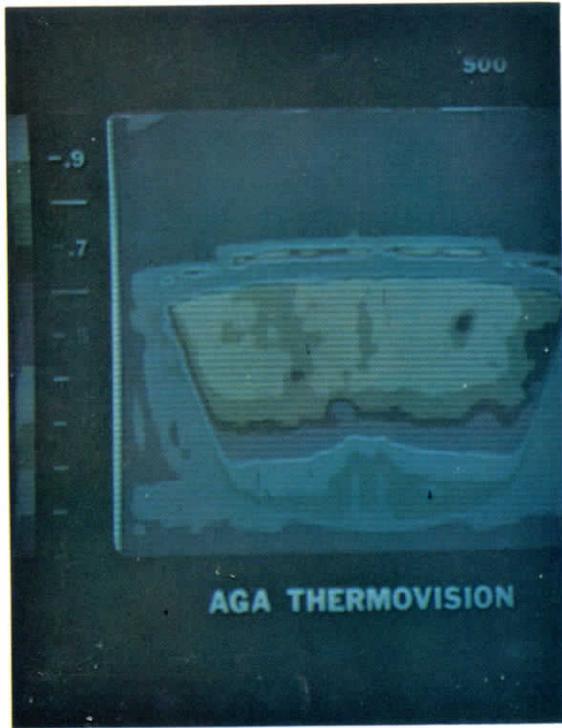
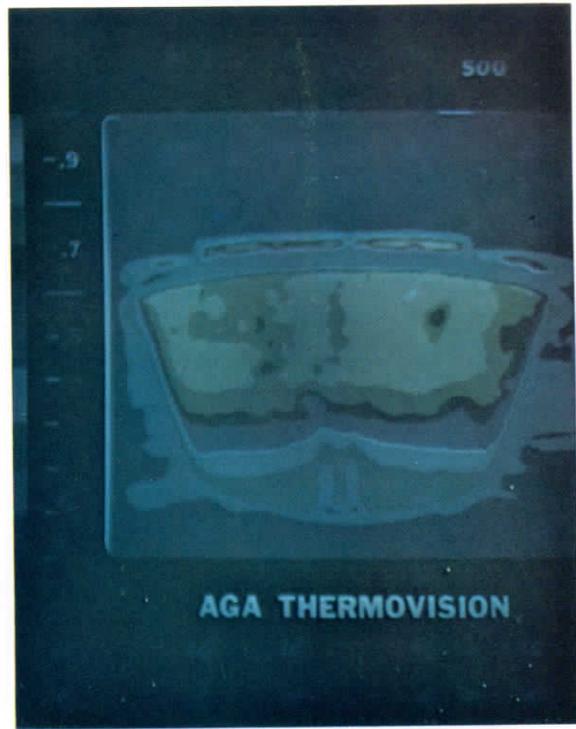
FIGURE 4

Figure 4 identified as E and A were taken during Heat No. 15 and show a heat pattern on the surface representing a temperature range of 205 degrees F. the coolest area (dark green) at the base is 328 to 376° F and the warmest area (yellow) reached 533° F. the bands represent the temperatures displayed on the color calibration chart.

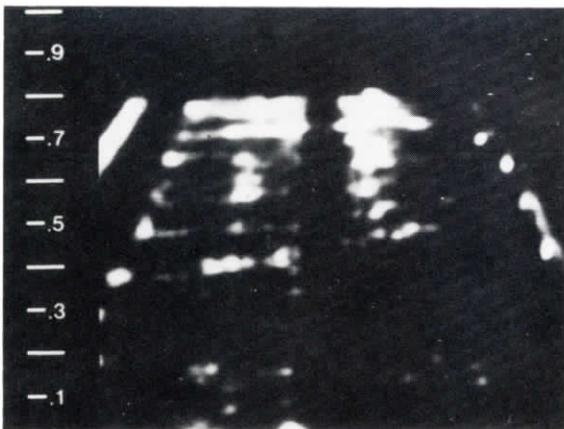
FIGURE 3a

A distinct isotherm pattern did exist and by taking three or more consecutive but separate pictures, each with a different isotherm level, it is possible to build up a composite thermal picture and present this in a simplified graphic form. Figure 3a shows a general thermographic picture of the bed, the lighter shades being the hotter areas. In Figure 3b an isotherm representing a temperature of 145°C has been superimposed on the thermal picture. The graphic representation is shown in Figure 3c and as can be seen although there was a distinct pattern it did not conform to our ideal. Factors which could affect this pattern had to be considered, i.e. uneven ignition and spreader faults affecting permeability being the most suspect. No apparent spreader faults were visible and an even, unbroken bed of sinter was being produced with no irregularities. Although hidden faults could not be ruled out, it seemed more likely to be an ignition problem.

Shortly after this survey, all the burners in the ignition hood were replaced and some were found to be partially blocked with ammonium thiocyanate, a byproduct of the coke oven gas burned. A second survey was carried out shortly after this overhaul and the results clearly showed a great improvement, the thermographic pattern approaching that of the idealised thermogram. These results are shown in Figure 4a and graphic form in Figure 4b.

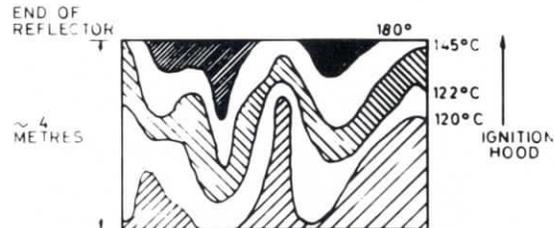
FIGURE 3c GRAPH SHOWING ISOTHERMS ON THE SURFACE OF A SINTER STRAND

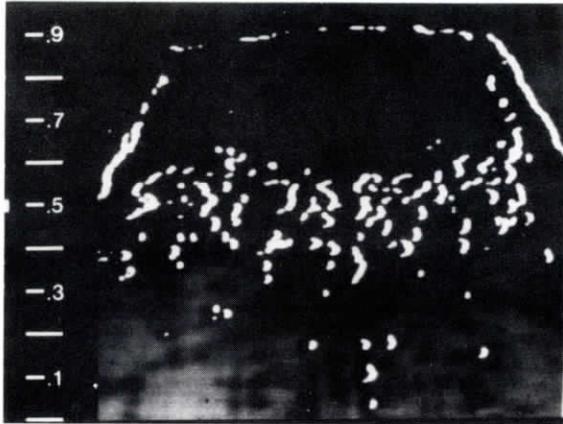
FIGURE 4a

As a result of this overhaul the percentage of returned fines being produced was reduced considerably and theoretically the strand speed could have increased, thus increasing throughput.

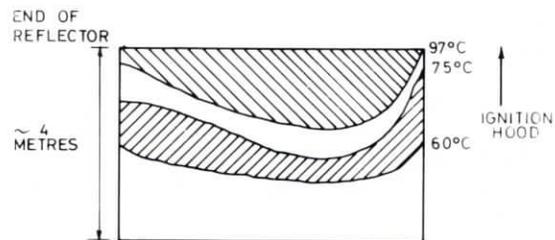
FIGURE 4b GRAPH SHOWING ISOTHERMS ON THE SURFACE OF A SINTER STRAND

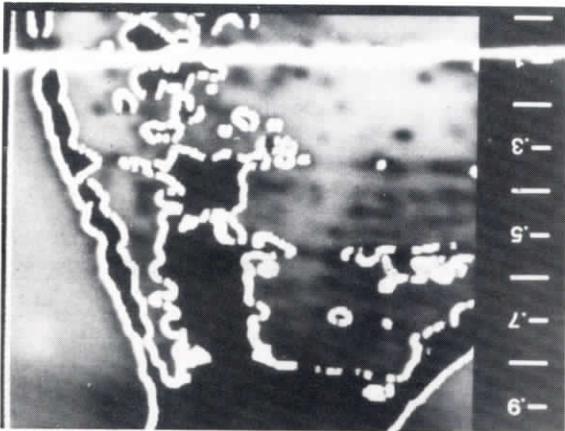
FIGURE 6a

supplied with gas from both ends, each end having a regulating valve. This particular strand's burners had all been changed fairly recently, no thermographic survey having been carried out previously. Pictures obtained showed up what appeared to be obvious ignition faults. Figures 6a and 6b indicate (according to our theory) preferential ignition occurring on the left hand side of the bed. This irregular ignition pattern was unlikely to be due to any of the recently fitted burners being blocked, and after explaining the meaning of the thermogram to a member of plant personnel, on his own initiative he made adjustments to gas flows on the ignition system in an attempt to correct the irregular pattern. Figures 7a and 7b taken 20 minutes later shows the effects of these adjustments. Preferential ignition is now occurring at either side of the centre and adjustments made to achieve this were limited to one side of the ignition system. It appears now with both side gas flows balanced, the pressure drop across the outer burners causes gas starvation to the inner burners indicating poor burner design and/or poor operating practice.

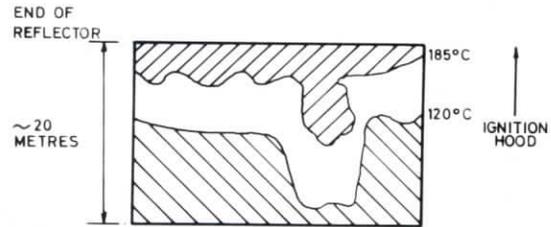
FIGURE 6b GRAPH SHOWING ISOTHERMS ON THE SURFACE OF A SINTER STRAND
