# TRANSMISSION LINE INSULATOR CONDITION MONITORING

*Transmission line insulator condition monitoring is of increasing interest with the ageing of many transmission lines constructed since the 1950s. Porcelain and toughened glass and more recently polymeric insulators all have characteristic degradation and pollution modes that must be considered by asset managers. Following the recent inspection of some 220 kV Transmission Line Insulators it is useful to summarise current understanding of ceramic insulator degradation and condition assessment.*

*By David Stuart McLennan – SP AusNet*

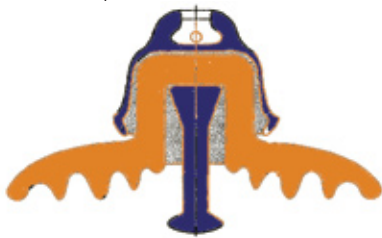
Figure 1 Section view of a porcelain insulator

Pin corrosion also limits the mechanical life of porcelain insulator strings. The extent of corrosion is normally determined visually and by sampling, mechanical testing and measurement of material loss.

Volume expansion of rust products inside the porcelain has been proposed as another source of porcelain radial cracking. Zinc sleeves and other modifications have been adopted in improved designs to delay the occurrence of pin corrosion.

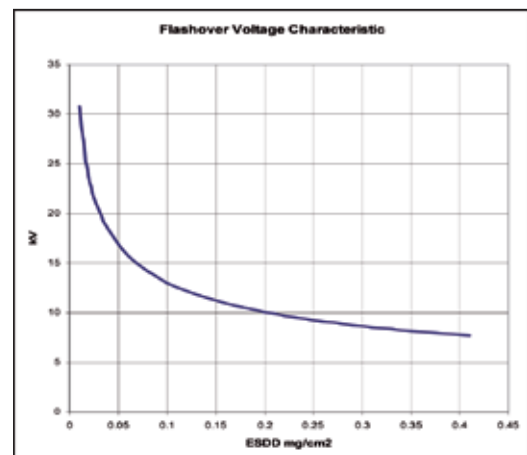
Figure 4 Insulator flashover characteristic

ESDD is the amount of common salt (NaCl) deposit that has the same conductivity as the insulator pollution deposit dissolved in the same volume of water. ESDD is the method that is commonly used in standards and by researchers for comparisons between insulator tests and models. Computer studies and experimental results show that a typical characteristic for flashover voltage versus pollution density (ESDD) is of the form shown in Figure 4.

This graph (Figure 4) shows why the electrical stress ageing is more intense close to the conductor. It appears that the strong electrical field in this region and the rain wash-down effect also encourages greater pollution deposition on the lower insulator units.

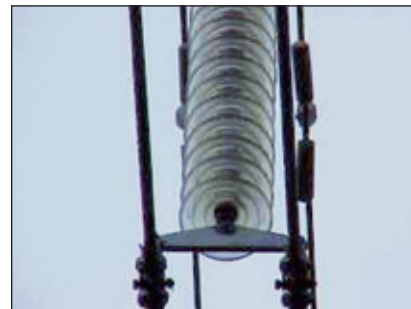
Figure 5 Glass insulator string

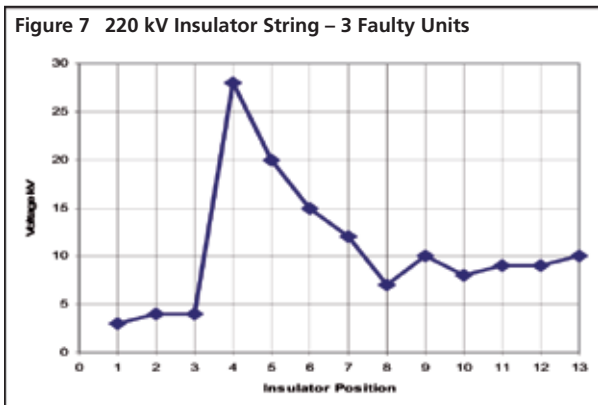
For SP AusNet the definitive confirming test (method 1) is to wash the insulators and then measure and plot the voltage across each one. The voltage curve should be fairly smooth (see Figure 6) and evenly distributed for insulators in good condition.

- i Voltage detection or measurements across each insulator live (see Figure 6 and Figure 7).
- ii Resistance measurement (Megger) of each insulator de-energised.
- iii Electric field measurement near each live insulator.

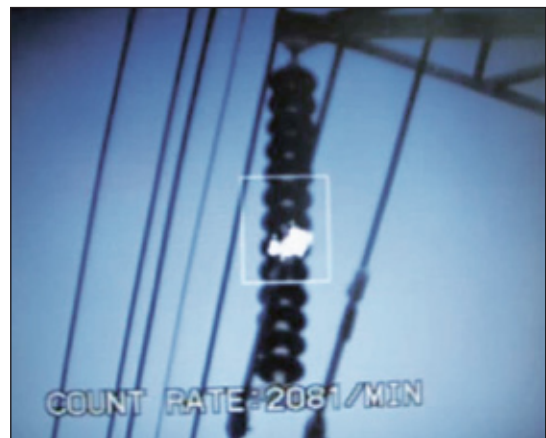
Figure 8 Corona caused by adjacent faulty insulators

The high field on the first good insulator after a low resistance insulator may be detected by an increase in corona using the corona camera and an increase in the temperature of the insulator above ambient using an infrared camera (about 3-5 °C above ambient).

If the corona camera and infrared camera detect a problem on a glass insulator it is almost certainly a pollution problem. If a corona camera and an infrared camera detect a high field on a porcelain string it may be caused by adjacent faulty insulators or by pollution. Very high intensity corona on one or two insulators is more likely to indicate faulty insulators causing a highly distorted electric field (see Figure 7 and Figure 8). Whereas pollution is more likely to produce a symmetrical situation i.e. light corona on many strings on the tower especially at the live end. Visual inspection with high- magnification stabilised binoculars can help identify a high pollution situation.
