We are pleased to provide the following NCI APPLICATION NOTE, once again showing the versatility of the DayCor® Camera and the cost savings possible from its use.

With the advent of Non Ceramic High Voltage Insulators, i.e. Insulators made of Plastic Polymer; a new importance is reached in the detection and eradication of Electric Corona on high-tension equipment such as overhead power lines and substations.

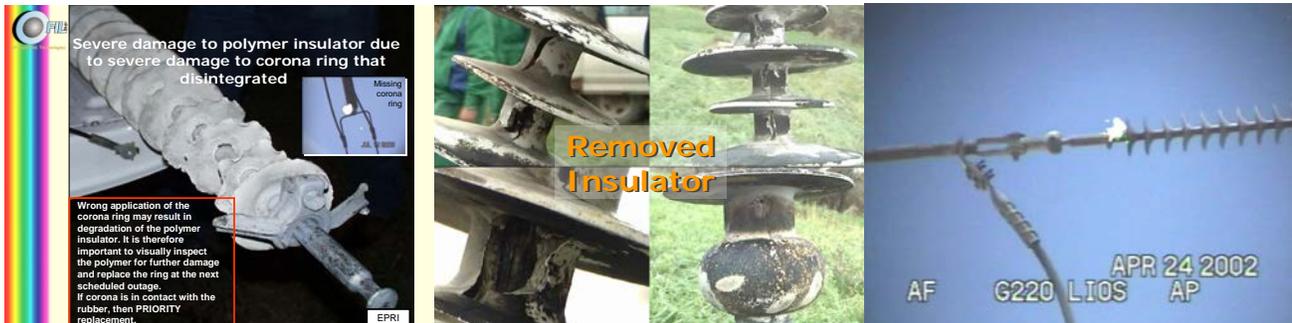
Above: Polymer Insulators with Corona Damage

Above: Missing Corona Ring

Many installed polymer insulators do not have protection for Corona damage. Some insulators are not equipped with grading Corona rings and others have damaged or missing rings. Some grading Corona rings are not installed correctly or may have the wrong design or size.

The invisible Corona on a polymer insulator and its hardware can seriously damage the insulator, resulting in flash-over or flash-under conditions. Electric Corona on a polymer insulator can damage the sheds and the membrane keeping the fiberglass rod system intact. If this happens pin holes can let moisture inside the protective membrane and the insulator will have an internal short. The Corona may also damage the insulator so that it sheers off. The Corona can corrode the insulator ends and jeopardize the structural integrity of the insulator. Electric Corona together with the Nitrogen and moisture in the air **produces** Ozone and **Nitric Acid!** **A no-no for Polymers.**

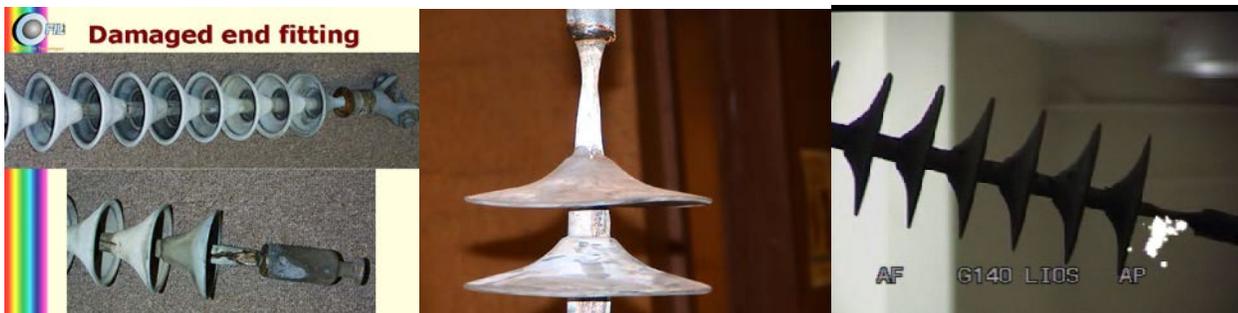
Above: Severe loss of material due to Corona.

Above: Faulty 110 kV Insulator Removed & Tested at 50 kV showing Corona!

In any of these cases, the possibility of a line drop is **real** and could happen at any time when Corona is existent on the insulator and damage has been done. The early detection of Electrical Corona is extremely important to keep the integrity of the electrical grid.
